**Flood Control Project Maintenance
Levee Inspections**

Fall 2015 Levee Maintenance Deficiency Summary Report

Sutter Maintenance Yard Maintenance Area 0013

Waterway			Bank	Unit Miles
Unit No. 01 Cherokee Canal			Right	18.19
	Spring (March - May)	Summer (June - August)	(September - November) Fall	Winter (December - February)
Unit Maintenance Rating (Fall Only)			A	
Date of Inspection	05/06/2015 - 05/06/2015		11/06/2015 - 11/06/2015	
DWR Inspector	Bob Duffey		Bob Duffey	
Accompanied By	Shawn Freitag Sutter Maintenance Yard		Shawn Freitag Sutter Maintenance Yard

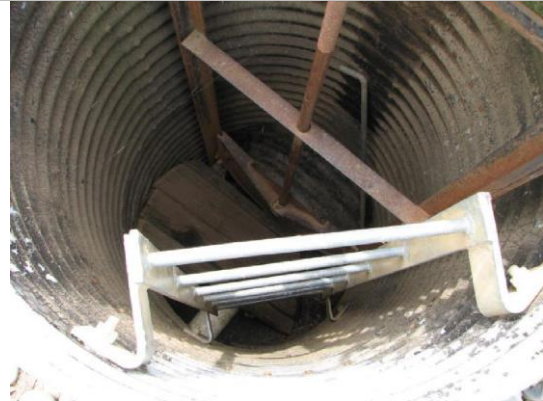
Photo 2 of 3 : UCIP_FA_2015_5398.jpg

Positive closure device on WS slope, panel lid fell in.

Action/Comments					
Inspector Comments: FS_ID:46352 DS_ID:16345 EP_NO: N/A FS_HLM: 1.697 Repair Type: Non-Urgent Crossing Status: Found UCIP Comments: 7/14/2015 4-inch pipe still present and blocking the screw gate. Crossing has 4-inch pipe inside blocking positive closure/notify landowner to remove prior to flood season. LS crossing is blocked about 50% by sediment build up. Burrow activity present on LS near crossing. 7/15/2013 Same as last inspection. 12/2/2013 Same as last inspection. 5/21/2014 Same as last inspection. FIELD_STRUCT_DESC: 24-inch corrugated metal irrigation pipe through the levee, 7.6 feet below the crown. Slide gate in corrugated metal pipe riser on the waterward slope. Concrete headwall on the landward side. 36-inch concrete standpipe in the channel with 2 piles to deflect debris (USACE-1960). This entry matches the Drainage or Irrigation Structure referenced in O&M manual (HLM 1.69). FS Date: 07/23/2015

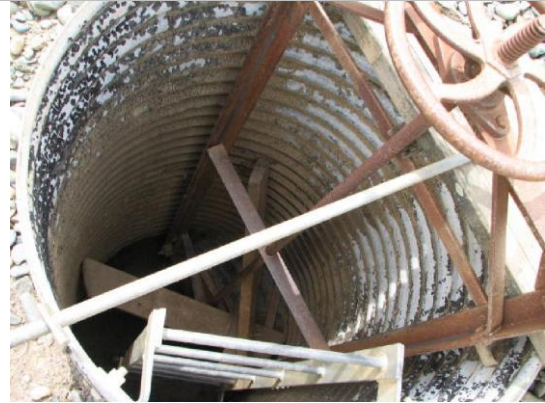
Photo 1 of 3 : UCIP_FA_2015_5400.jpg

Inspector Comments: FS_ID:46351
 DS_ID:16346
 EP_NO: N/A
 FS_HLM: 2.357
 Repair Type: Non-Urgent
 Crossing Status: Found
 UCIP Comments: 7/14/2015 Still cannot find an inlet or outlet. Non functional crossing due to LS headwall buried. This crossing was listed in the USACE Periodic Inspection report as Corp's inspect ID#USACE_CESPK_M13D_2011_p_0119 for no inlet or outlet visible. 7/15/2013 Same as last inspection. 12/2/2013 Same as last inspection. 5/21/2014 Same as last inspection.
 FIELD_STRUCT_DESC: 24-inch corrugated metal irrigation pipe through the levee 7.8 feet below the crown. Slide gate in corrugated metal pipe riser on the waterward slope. Pipe continues across channel. Concrete "U" headwall on the landward side. (USACE-1960). This entry matches the Drainage or Irrigation Structure referenced in O&M manual (HLM 2.35).
 FS Date: 07/23/2015

Corrugated metal riser on WS slope. Lid panel blocking gate.

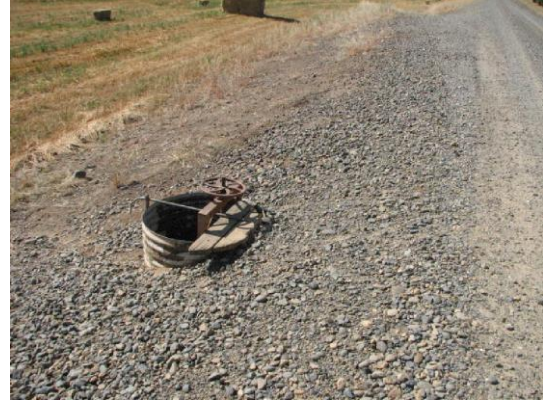
Photo 3 of 3 : UCIP_FA_2015_5402.jpg

LM Start	2.31	Rating **	M	Issue No.	49 (cont)
LM End	2.31	Issue Type +	En	Location *	LS
Category	Supplemental			GPS Latitude/Longitude	
				Start	End
Item	DWR UCIP Field Study			39.566433 °	39.566433 °
				-121.703750 °	-121.703750 °
DWR ID					
Action/Comments					
Inspector Comments: FS_ID:46351 DS_ID:16346 EP_NO: N/A FS_HLM: 2.357 Repair Type: Non-Urgent Crossing Status: Found UCIP Comments: 7/14/2015 Still cannot find an inlet or outelt.Non functional crossing due to LS headwall buried. This crossing was listed in the USACE Periodic Inspection report as Corp's inspect ID#USACE_CESPK_M13D_2011_p_0119 for no inlet or outlet visible.7/15/2013 Same as last inspection.12/2/2013 Same as last inspection.5/21/2014 Same as last inspection. FIELD_STRUCT_DESC: 24-inch corrugated metal irrigation pipe through the levee 7.8 feet below the crown. Slide gate in corrugated metal pipe riser on the waterward slope. Pipe continues across channel. Concrete "U" headwall on the landward side. (USACE-1960). This entry matches the Drainage or Irrigation Structure referenced in O&M manual (HLM 2.35). FS Date: 07/23/2015

Corrugated riser located on WS slope.

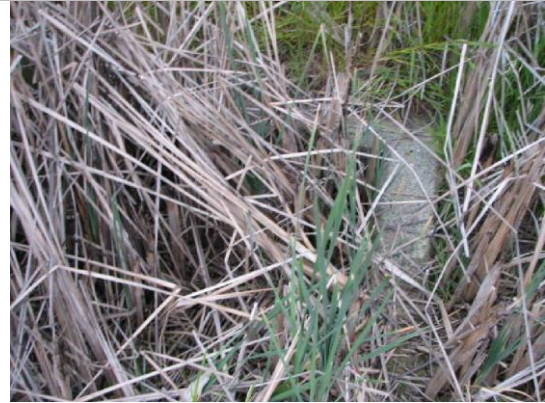
Photo 1 of 4 : UCIP_FA_2015_5533.jpg

WS flap gate blocked by debris.

Action/Comments					
Inspector Comments: FS_ID:46344					
DS_ID:16365					
EP_NO: N/A					
FS_HLM: 3.803					
Repair Type: Urgent					
Crossing Status: Found					
UCIP Comments: 7/14/2015 LS screw gate is still damaged and buried. Crossing is non-functional. LS slide gate covered with silt. Slide gate is bent. Crossing appears not be in use. Limited inspection on WS and LS slope due to dense vegetation. Need photos of cleared slopes. 7/15/2013 Slopes have been cleared of vegetation and are in good condition. LS screw gate is still bent and silted over. 12/2/2013 Same as last inspection. 5/21/2014 Same as last inspection.					
FIELD_STRUCT_DESC: 24-inch corrugated metal drainpipe through the levee, 7.9 feet below the crown. Flap gate on the waterward end. Screw gate on the landward end. Concrete "U" headwalls on both ends (USACE-1960). This entry matches the Drainage or Irrigation Structure referenced in O&M manual (HLM 3.82).

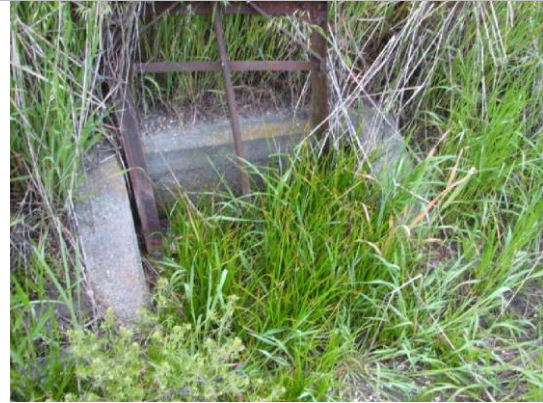
Photo 2 of 4 : UCIP_FA_2015_5534.jpg

Action/Comments					
Inspector Comments: FS_ID:46344 DS_ID:16365 EP_NO: N/A FS_HLM: 3.803 Repair Type: Urgent Crossing Status: Found UCIP Comments: 7/14/2015 LS screw gate is still damaged and buried. Crossing is non-functional. LS slide gate covered with silt. Slide gate is bent. Crossing appears not be in use. Limited inspection on WS and LS slope due to dense vegetation. Need photos of cleared slopes. 7/15/2013 Slopes have been cleared of vegetation and are in good condition. LS screw gate is still bent and silted over. 12/2/2013 Same as last inspection. 5/21/2014 Same as last inspection. FIELD_STRUCT_DESC: 24-inch corrugated metal drainpipe through the levee, 7.9 feet below the crown. Flap gate on the waterward end. Screw gate on the landward end. Concrete "U" headwalls on both ends (USACE-1960). This entry matches the Drainage or Irrigation Structure referenced in O&M manual (HLM 3.82). FS Date: 07/23/2015

LS slide gate covered with silt. Slide gate is bent.

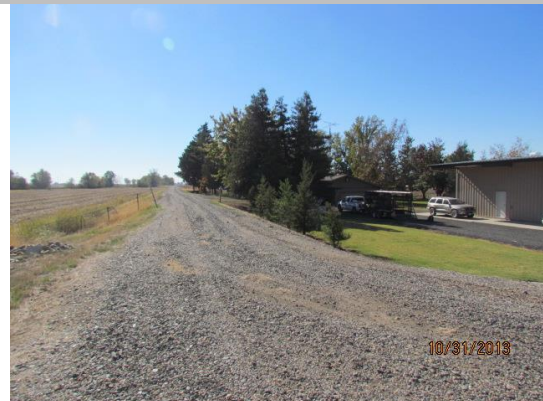
Photo 1 of 1 : FA_2015_MA0013_300_18_20150910_00008.jpg

LM Start	4.06	Rating **	M	Issue No.	18
LM End	4.13	Issue Type +	En	Location *	LS
Category	Earthen Levee			GPS Latitude/Longitude	
				Start	End
Item	Vegetation			39.541660 °	39.540651 °
				-121.707408 °	-121.707404 °
DWR ID	DWR_MA0013_01_s_2013_18				
Action/Comments					
Landscaping

View of the redwood trees along the landside slope.

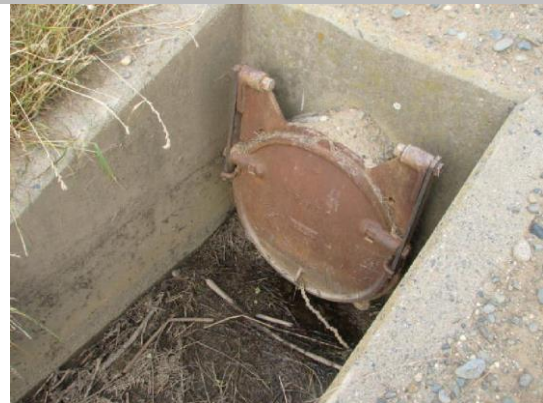
Photo 1 of 3 : UCIP_FA_2015_4388.jpg

Flap gate WS

Action/Comments					
Inspector Comments: FS_ID:46277 DS_ID:16360 EP_NO: N/A FS_HLM: 5.964 Repair Type: Non-Urgent Crossing Status: Found UCIP Comments: 7/13/2015 LS screw gate was completely submerged but crossing appears to be in good condition. Burrow activity near crossing; burrow holes present on LS. 7/15/2013 Same as last inspection. 12/2/2013 Same as last inspection. 5/21/2014 Same as last inspection. FIELD_STRUCT_DESC: 24-inch corrugated metal drainpipe through the levee, 6.2 feet below the crown. Flap gate on the waterward end. Slide gate on the landward end. Concrete "U" headwalls on both ends (USACE-1960). This entry matches the Drainage or Irrigation Structure referenced in O&M manual (HLM 5.97). FS Date: 07/17/2015

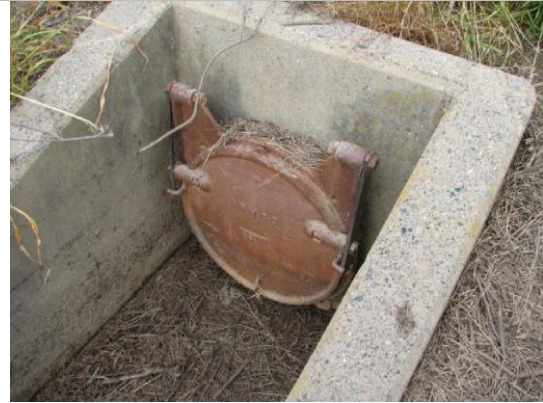
Photo 1 of 3 : UCIP_FA_2015_4391.jpg

LM Start	6.23	Rating **	U	Issue No.	55
LM End	6.23	Issue Type +	En	Location *	CR
Category	Supplemental			GPS Latitude/Longitude	
				Start	End
Item	DWR UCIP Field Study			39.511337 °	39.511337 °
				-121.713620 °	-121.713620 °
DWR ID					
Action/Comments					
Inspector Comments: FS_ID:46278					
DS_ID:16361					
EP_NO: N/A					
FS_HLM: 6.327					
Repair Type: Urgent					
Crossing Status: Found

View of WS flap gate.

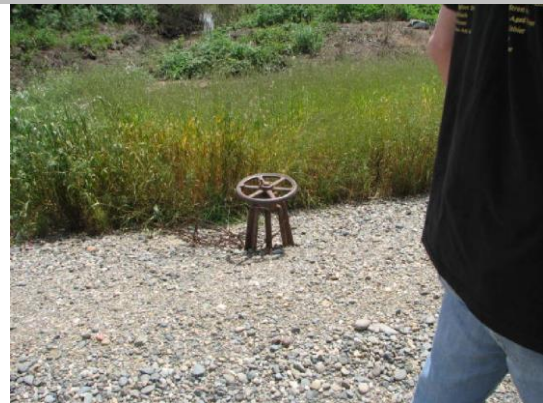
Photo 1 of 2 : UCIP_FA_2015_5267.jpg

Buried slide gate on the WS slope.

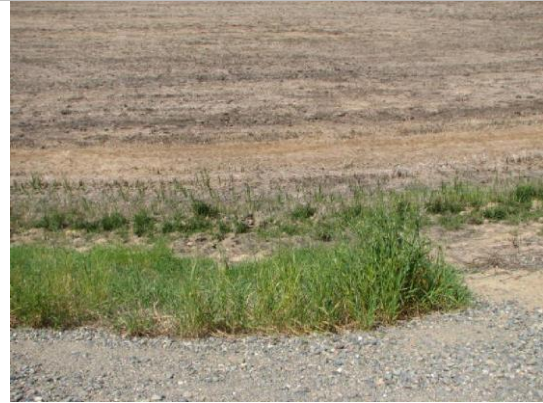
Photo 2 of 2 : UCIP_FA_2015_5268.jpg

View of LS slope and toe. Unable to find welded plate on LS.

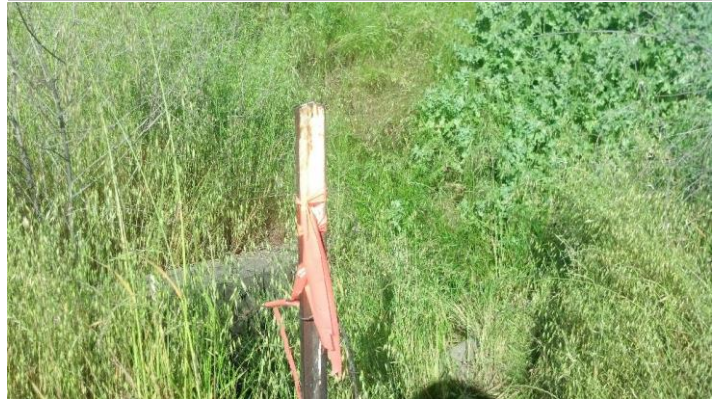
Photo 3 of 3 : UCIP_FA_2015_5323.jpg

Dense vegetation covering the majority of the WS. WS headwall difficult to see through dense vegetation.

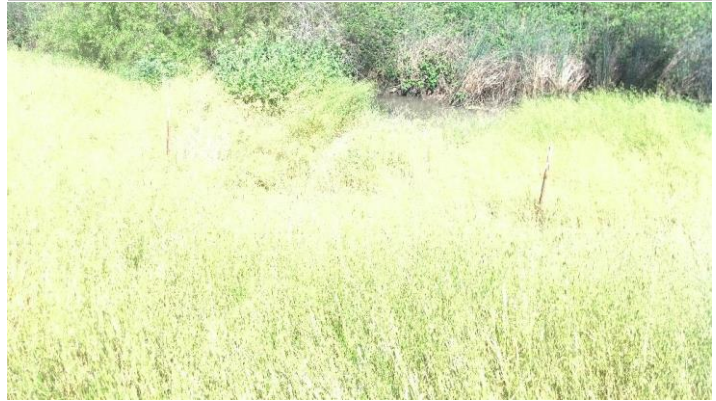
Photo 2 of 3 : UCIP_FA_2015_5325.jpg

View of WS slope. Limited inspection due to the dense vegetation.

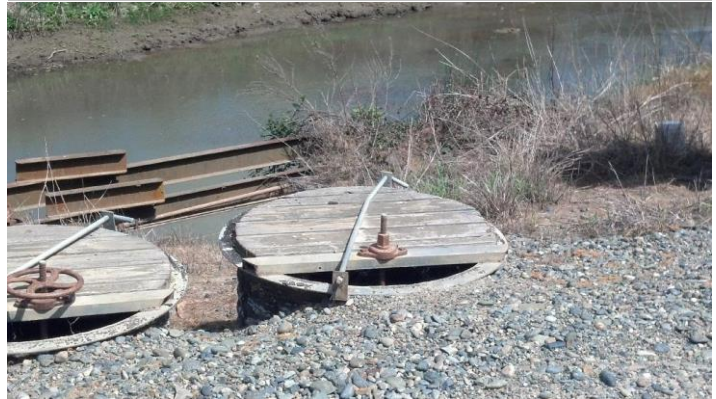
Photo 2 of 3 : UCIP_FA_2015_3764.jpg

Corrugated metal pipe riser for pipe 1 of 3. Slide gate is missing handle.

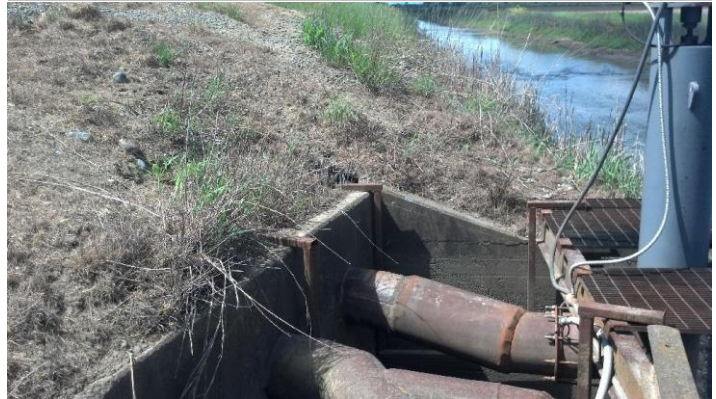
Photo 3 of 3 : UCIP_FA_2015_3765.jpg

Sink hole observed behind WS headwall at the downstream edge of headwall. (Sink hole picture 1 of 2)

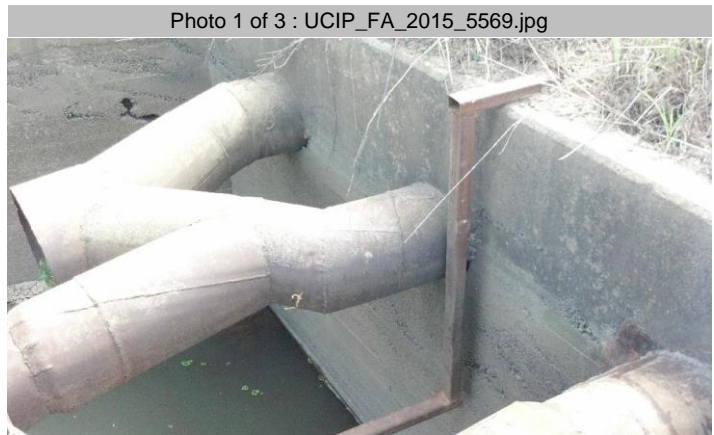
Action/Comments					
Inspector Comments: FS_ID:46254					
DS_ID:17014					
EP_NO: N/A					
FS_HLM: 21.002					
Repair Type: Urgent					
Crossing Status: Found					
UCIP Comments: 6/30/2015 Crossing has not been repaired yet. pipe ends still showing heavy signs of rust and corrosion. LS pipe collars severely damaged--section missing at flapgate. Crossing needs repair. Will need to coordinate with owner. 7/8/2013 Same as last inspection. 12/4/2013 Same as last inspection. 5/28/2014 Same as last inspection.					
FIELD_STRUCT_DESC: 2 of 3: 16-inch steel pipe encased in reinforced concrete through the levee, 9.7 feet below the crown. Concrete "U" headwall on both ends. Slide gates on corrugated metal pipe risers on the waterward slope. Pump structure on the waterward end (USACE-1960). This entry matches the Drainage or Irrigation Structure referenced in O&M manual (HLM 21.00).					
FS Date: 07/16/2015

View of pipe 2. Pipe 2 diverts flow to pipe 1.

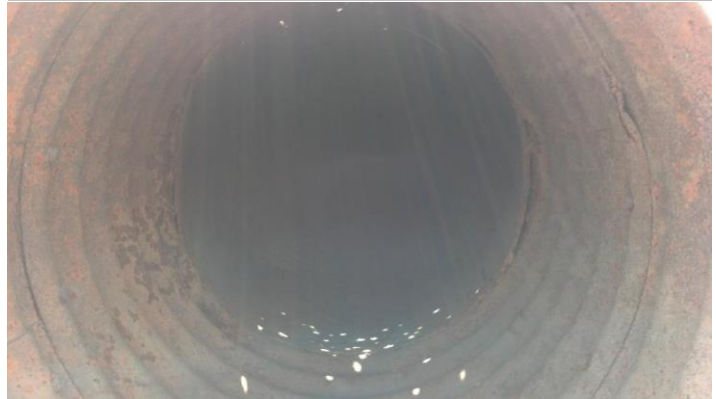
Photo 2 of 3 : UCIP_FA_2015_5576.jpg

WS-view of internal pipe with severe corrosion-holes present along pipe wall.

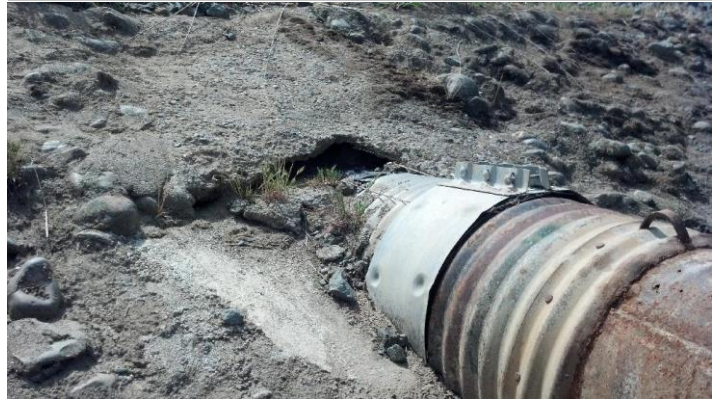
Photo 3 of 3 : UCIP_FA_2015_5577.jpg

View of WS daylight. Hole present at pipe daylight.
